ADVANCE REPORT  
on the  
SEDIMENTATION INVESTIGATIONS  
of  
RESERVOIRS AND NAVIGATION IMPROVEMENTS  
on the  
NEW RIVER, VIRGINIA AND WEST VIRGINIA

April 14 - May 22, 1936

Carl B. Brown and Farrell F. Barnes

Division of Research  
Section of Hydrodynamic Studies  
SCS-SS-6  
August, 1936

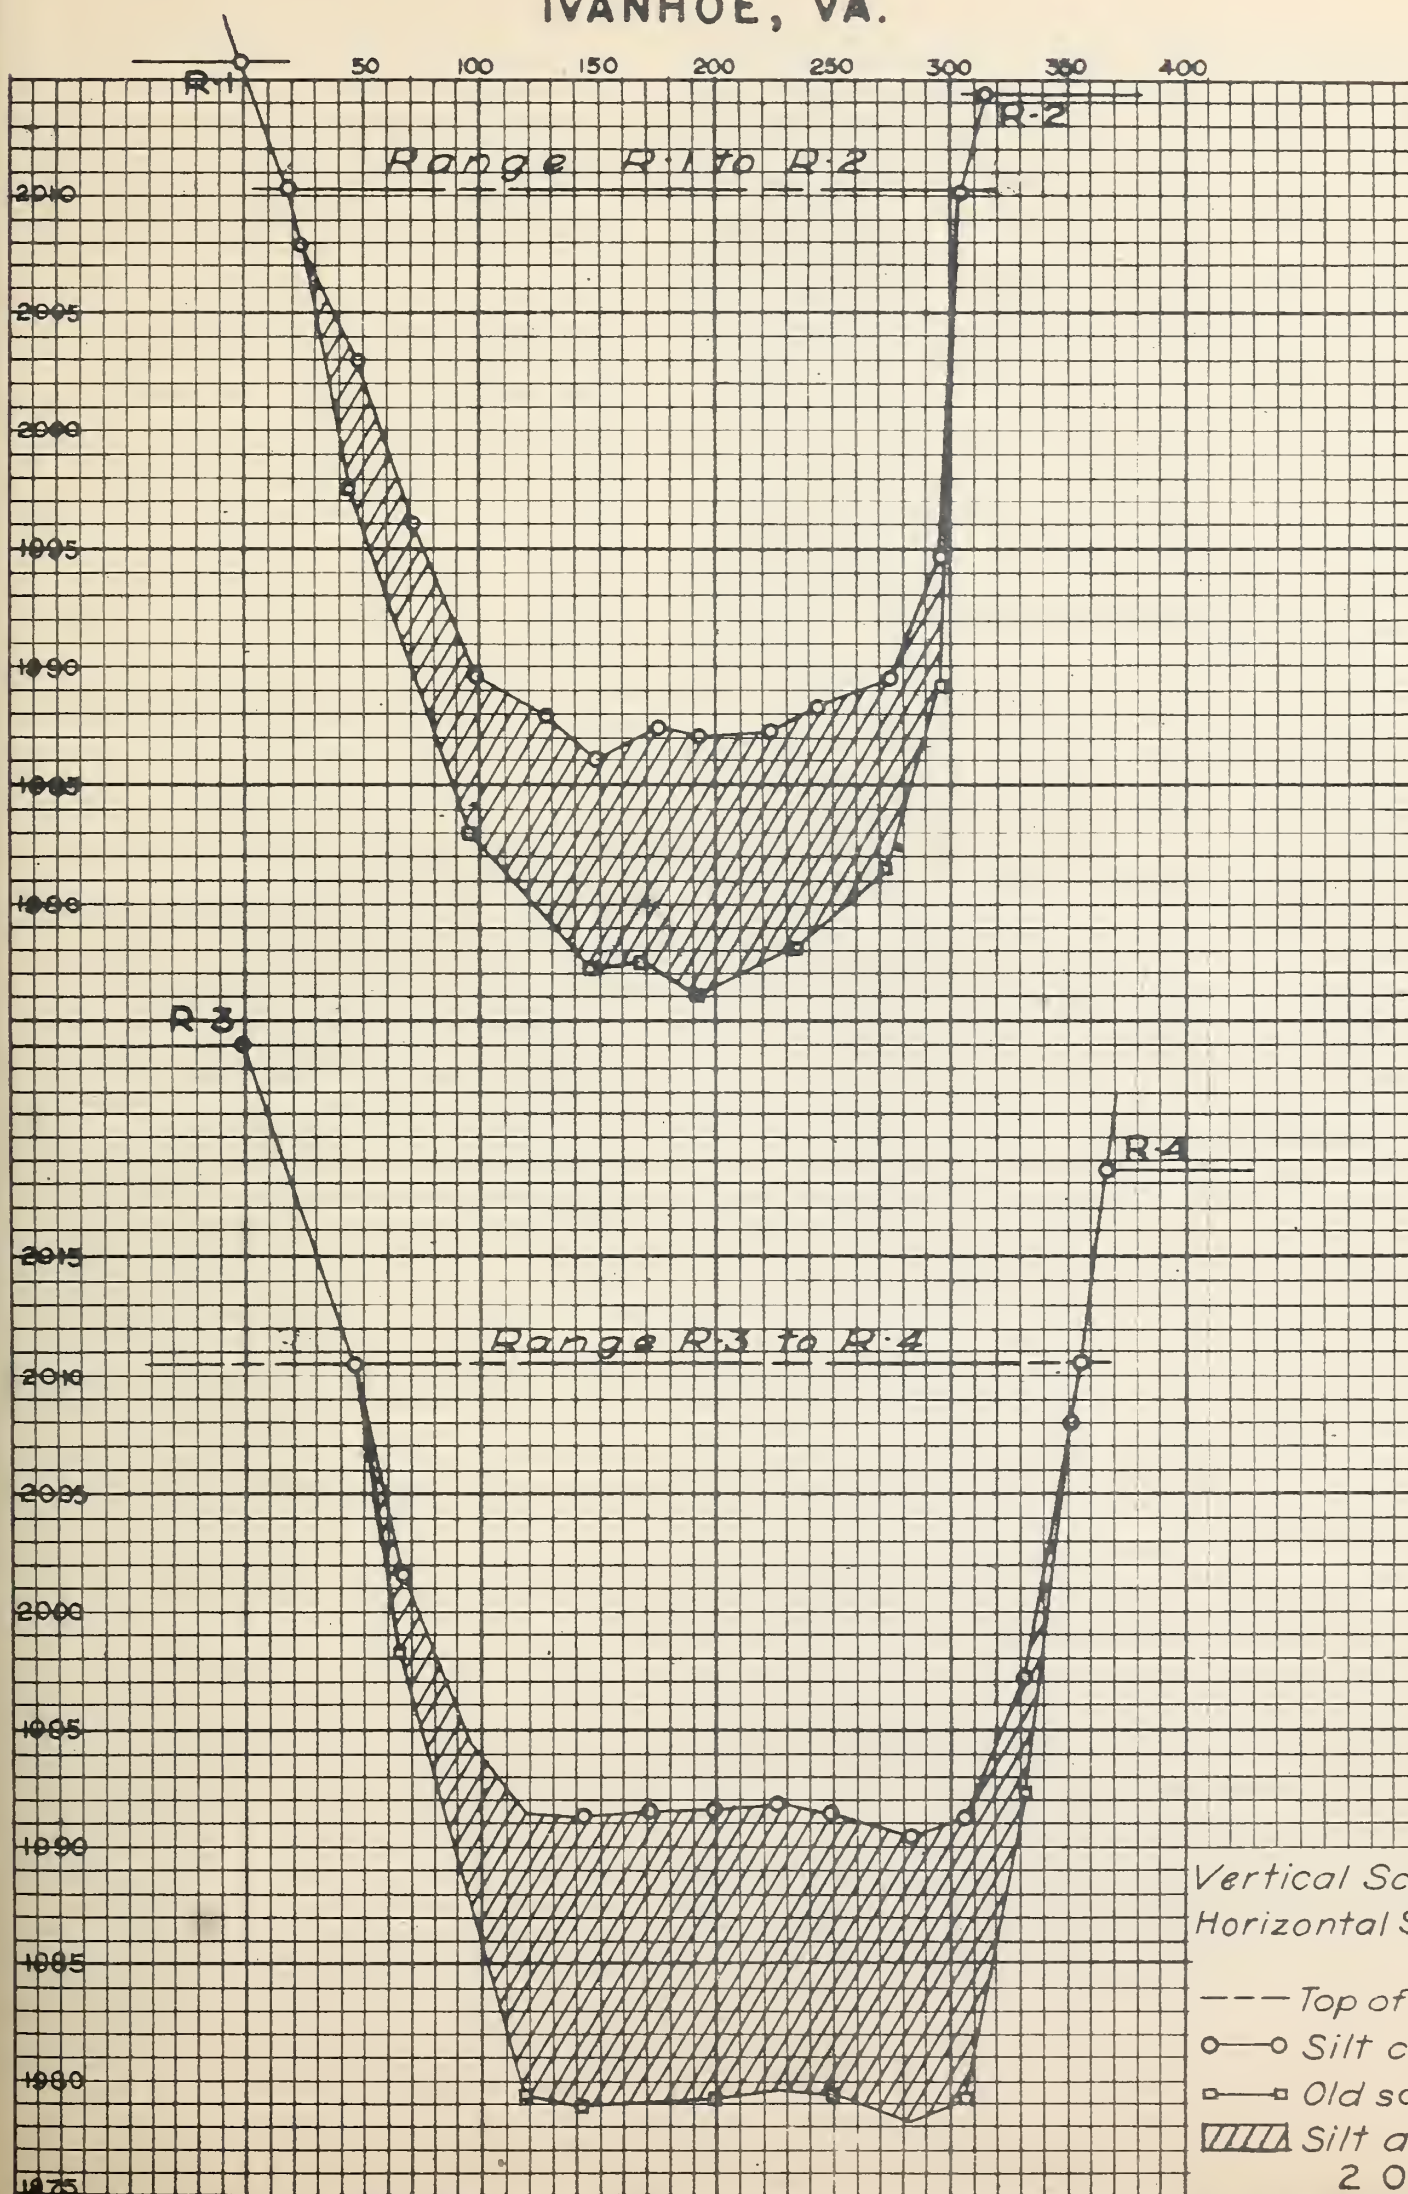
Fig. 21

# CROSS SECTIONS OF BUCK RESERVOIR IVANHOE, VA.

Vertical Scale: 1" = 10'  
Horizontal Scale: 1" = 100'

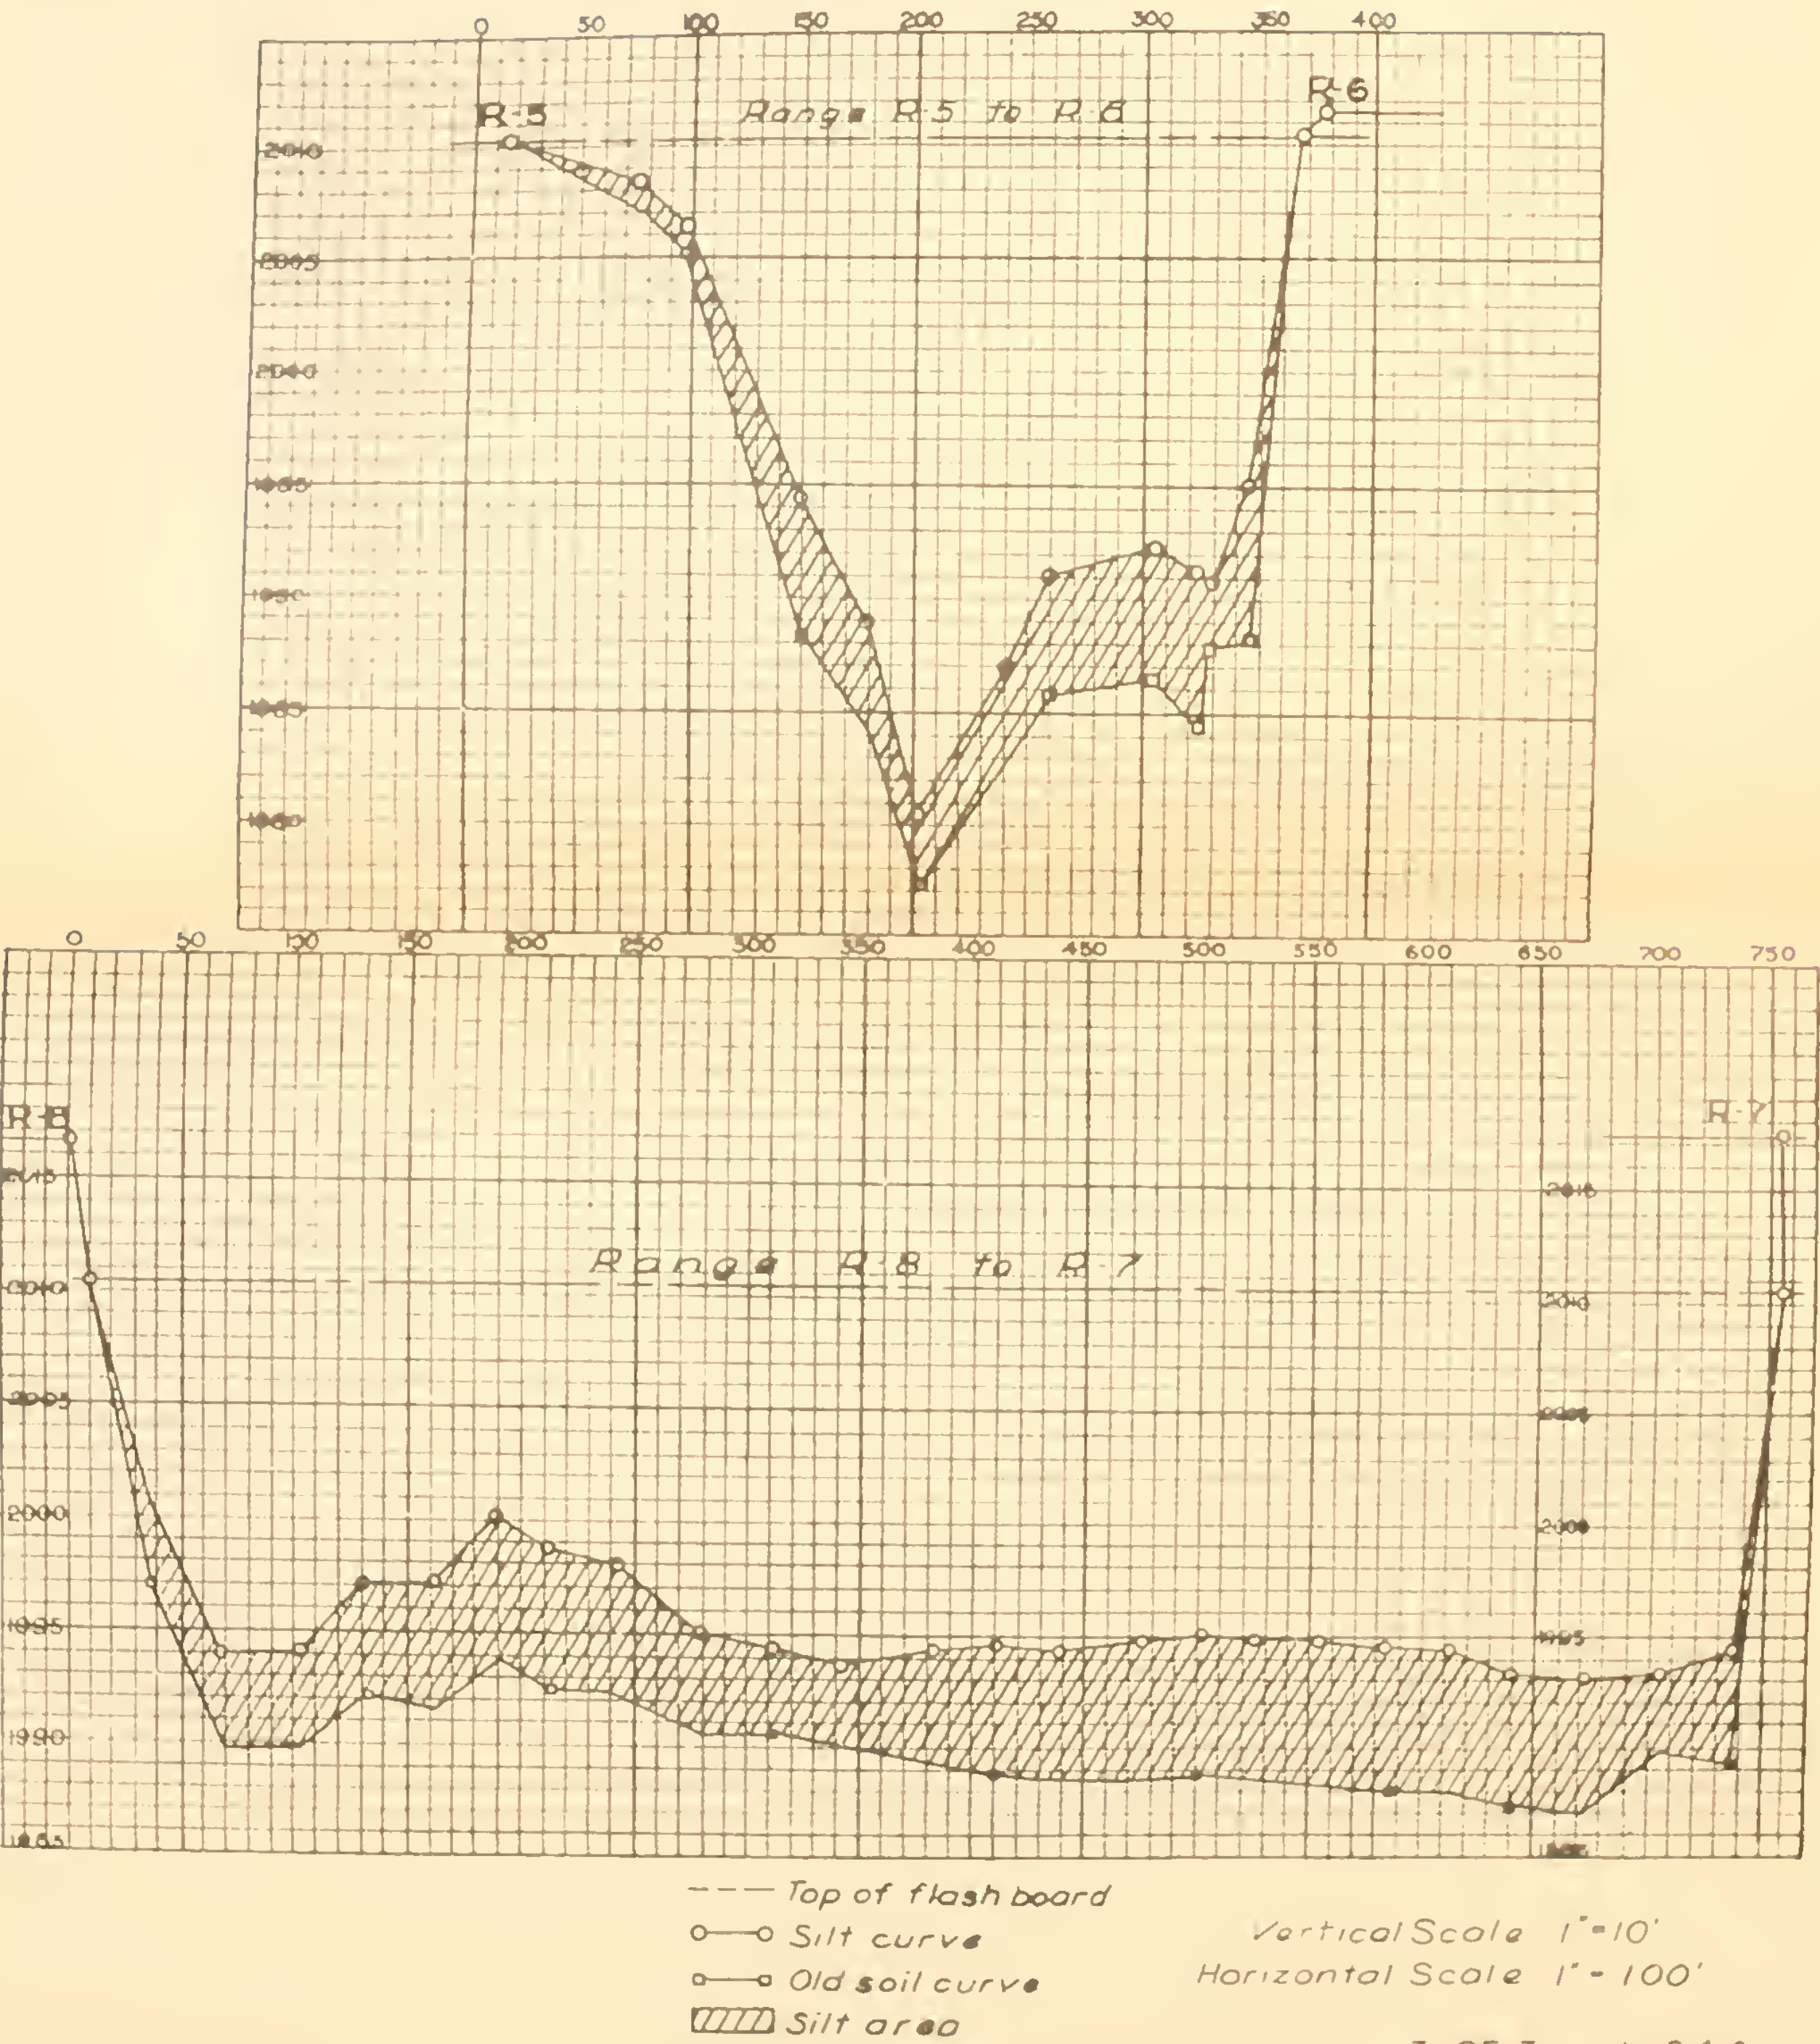
CROSS SECTIONS OF  
BUCK RESERVOIR  
IVANHOE, VA.

--- Top of flash board  
 o—o Silt curve  
 □—□ Old soil curve  
 ▨ Silt area

Vertical Scale: 1"=10'  
 Horizontal Scale: 1"=200'

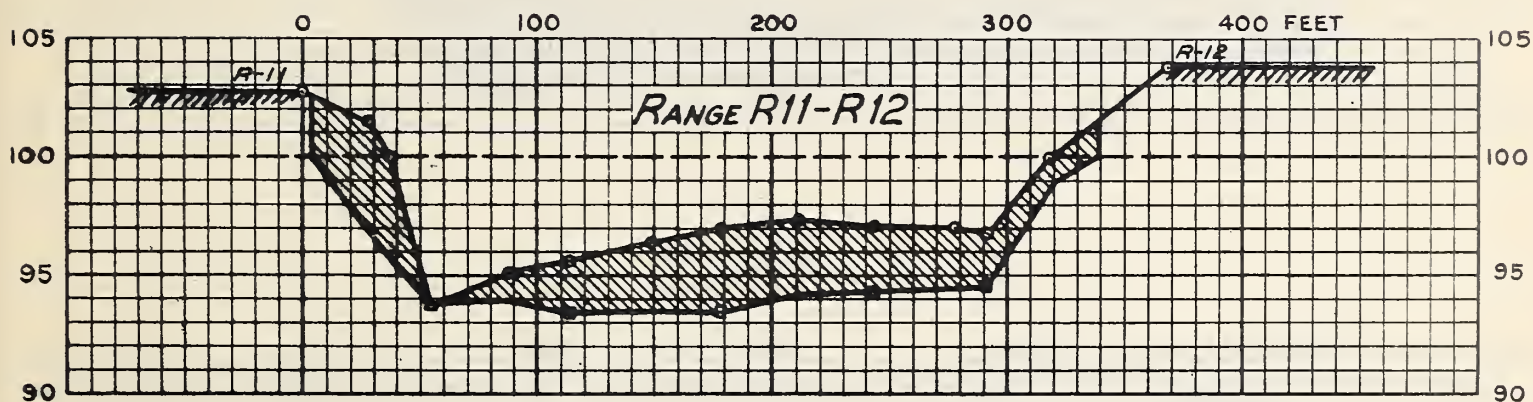
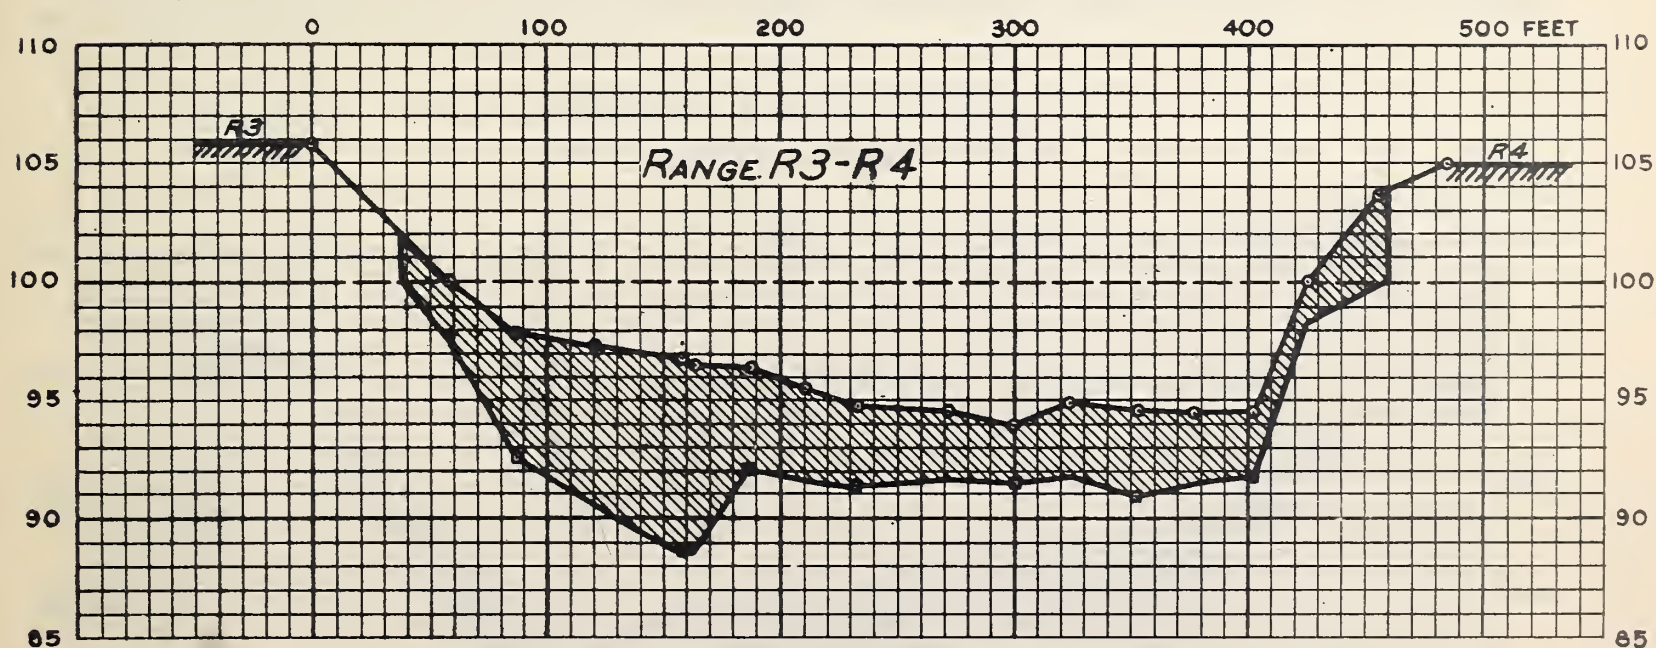
# CROSS SECTIONS OF FIELDS MANUFACTURING CO. LAKE INDEPENDENCE, VA.

*Vertical scale: 1" = 10'*  
*Horizontal scale: 1" = 100'*

--- = Top of flash-board  
 ●—● = Silt Curve  
 □—□ = Old Soil Curve

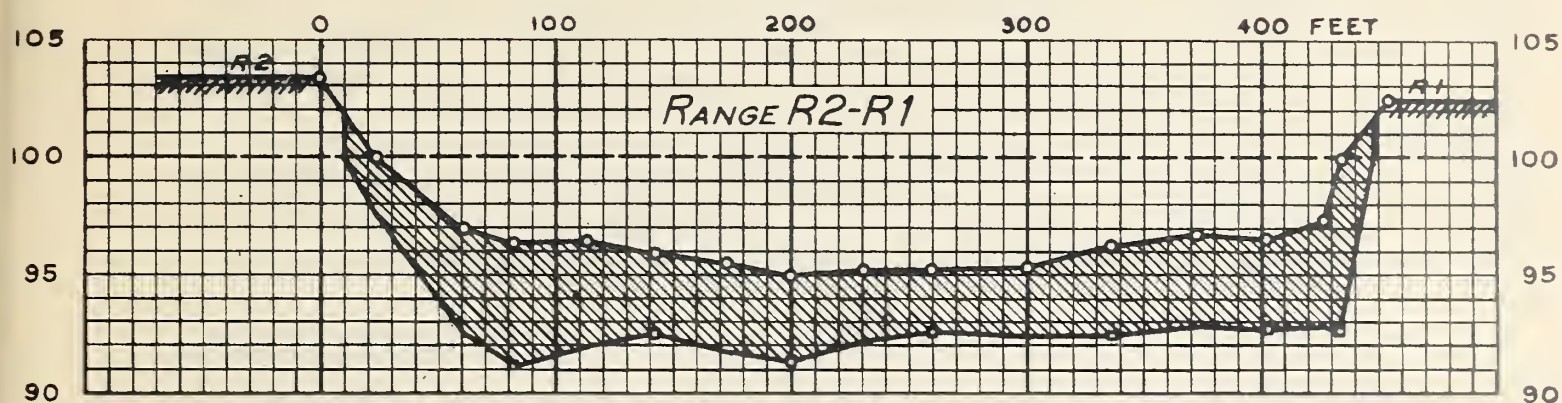
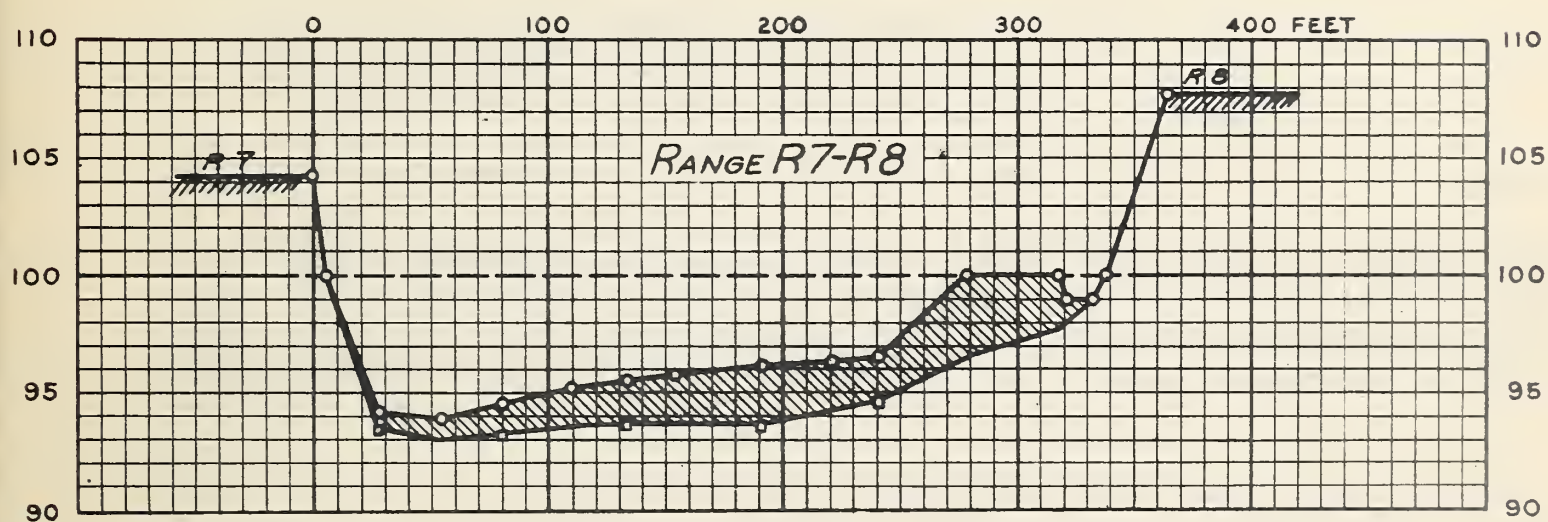
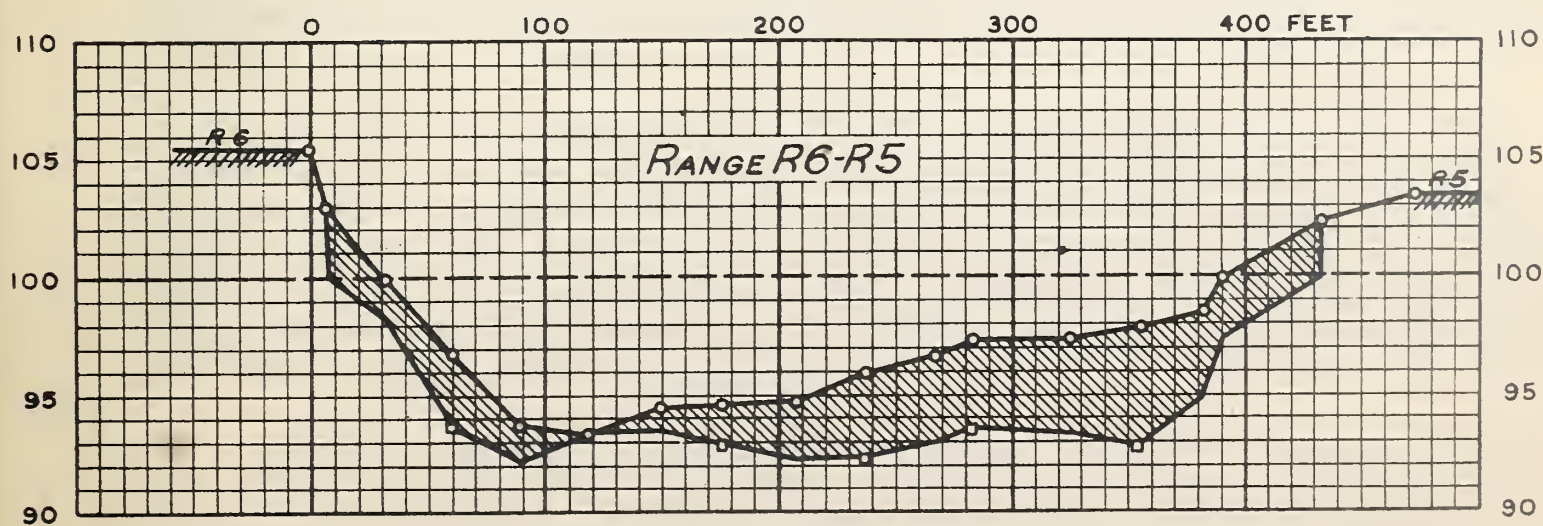
# CROSS SECTIONS OF FIELDS MANUFACTURING CO. LAKE INDEPENDENCE, VA.

*Vertical scale: 1"=10'*  
*Horizontal scale: 1"=100'*

- - - = Top of Flash-board  
 ● — ● = Silt Curve  
 ■ — ■ = Old Soil Curve

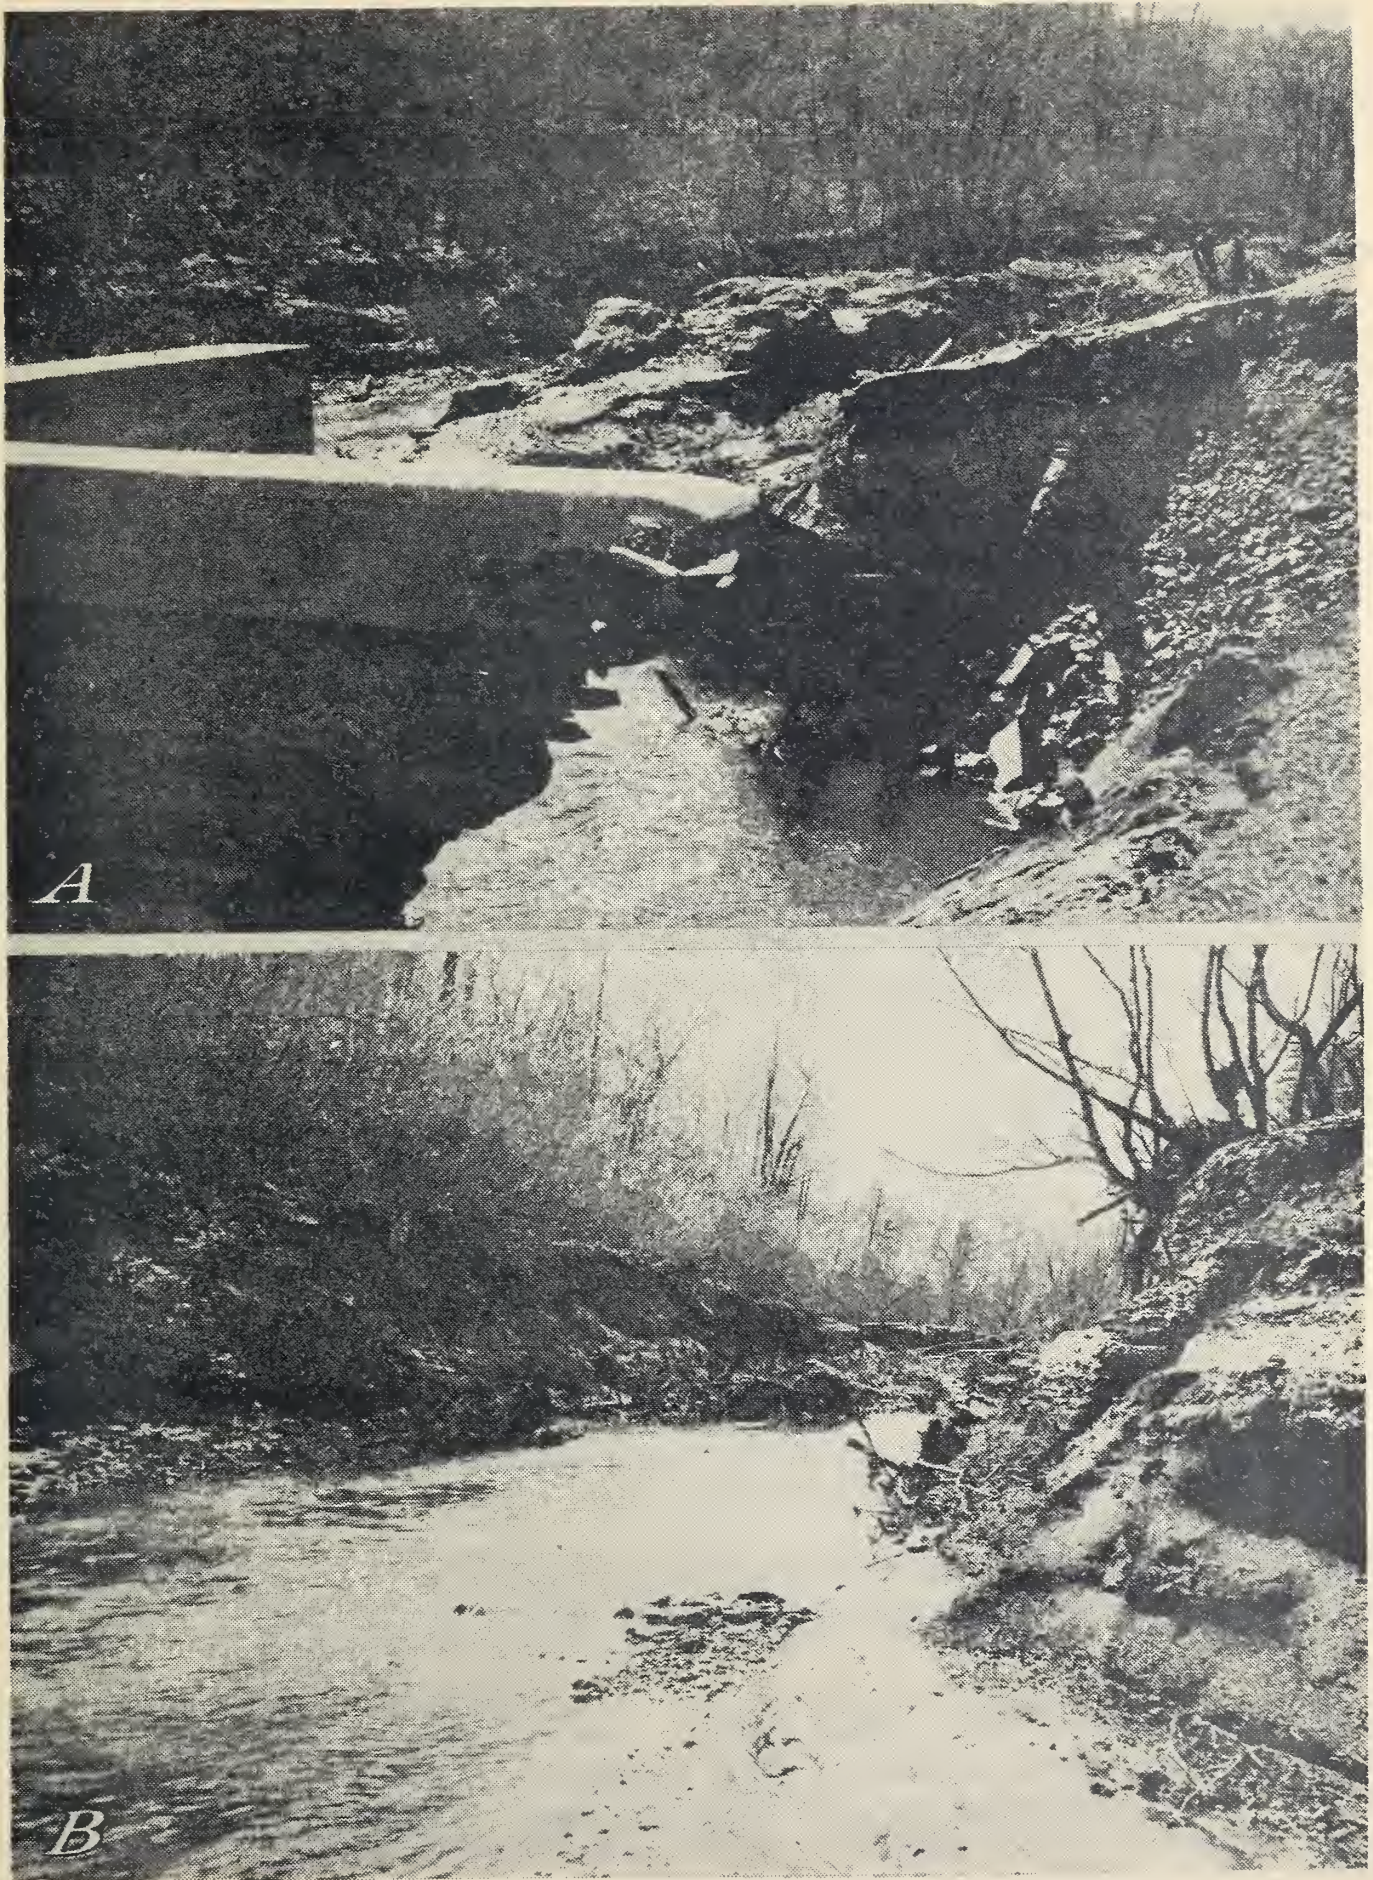
Figure 25.A. View of break in Poplar Branch Dam, south of Jackson's Ferry, washed out in March 1936. B. View of silt deposits above Poplar Branch Dam, and the channel cut following the break of March 1936.

A striking example is Poplar Branch Dam, on a small tributary of the New River, just south of Jackson's Ferry on the Carroll-Wythe county line, Virginia. In March 1936 this small concrete dam, about 15 feet high, washed out around one abutment down to the level of bedrock (fig. 25a), exposing a complete section of the silt deposits (fig. 25b). The deposits were found to have been built up practically to the crest level of the dam except for a narrow channel about 12 feet wide and said to have been 12 feet deep at the dam.

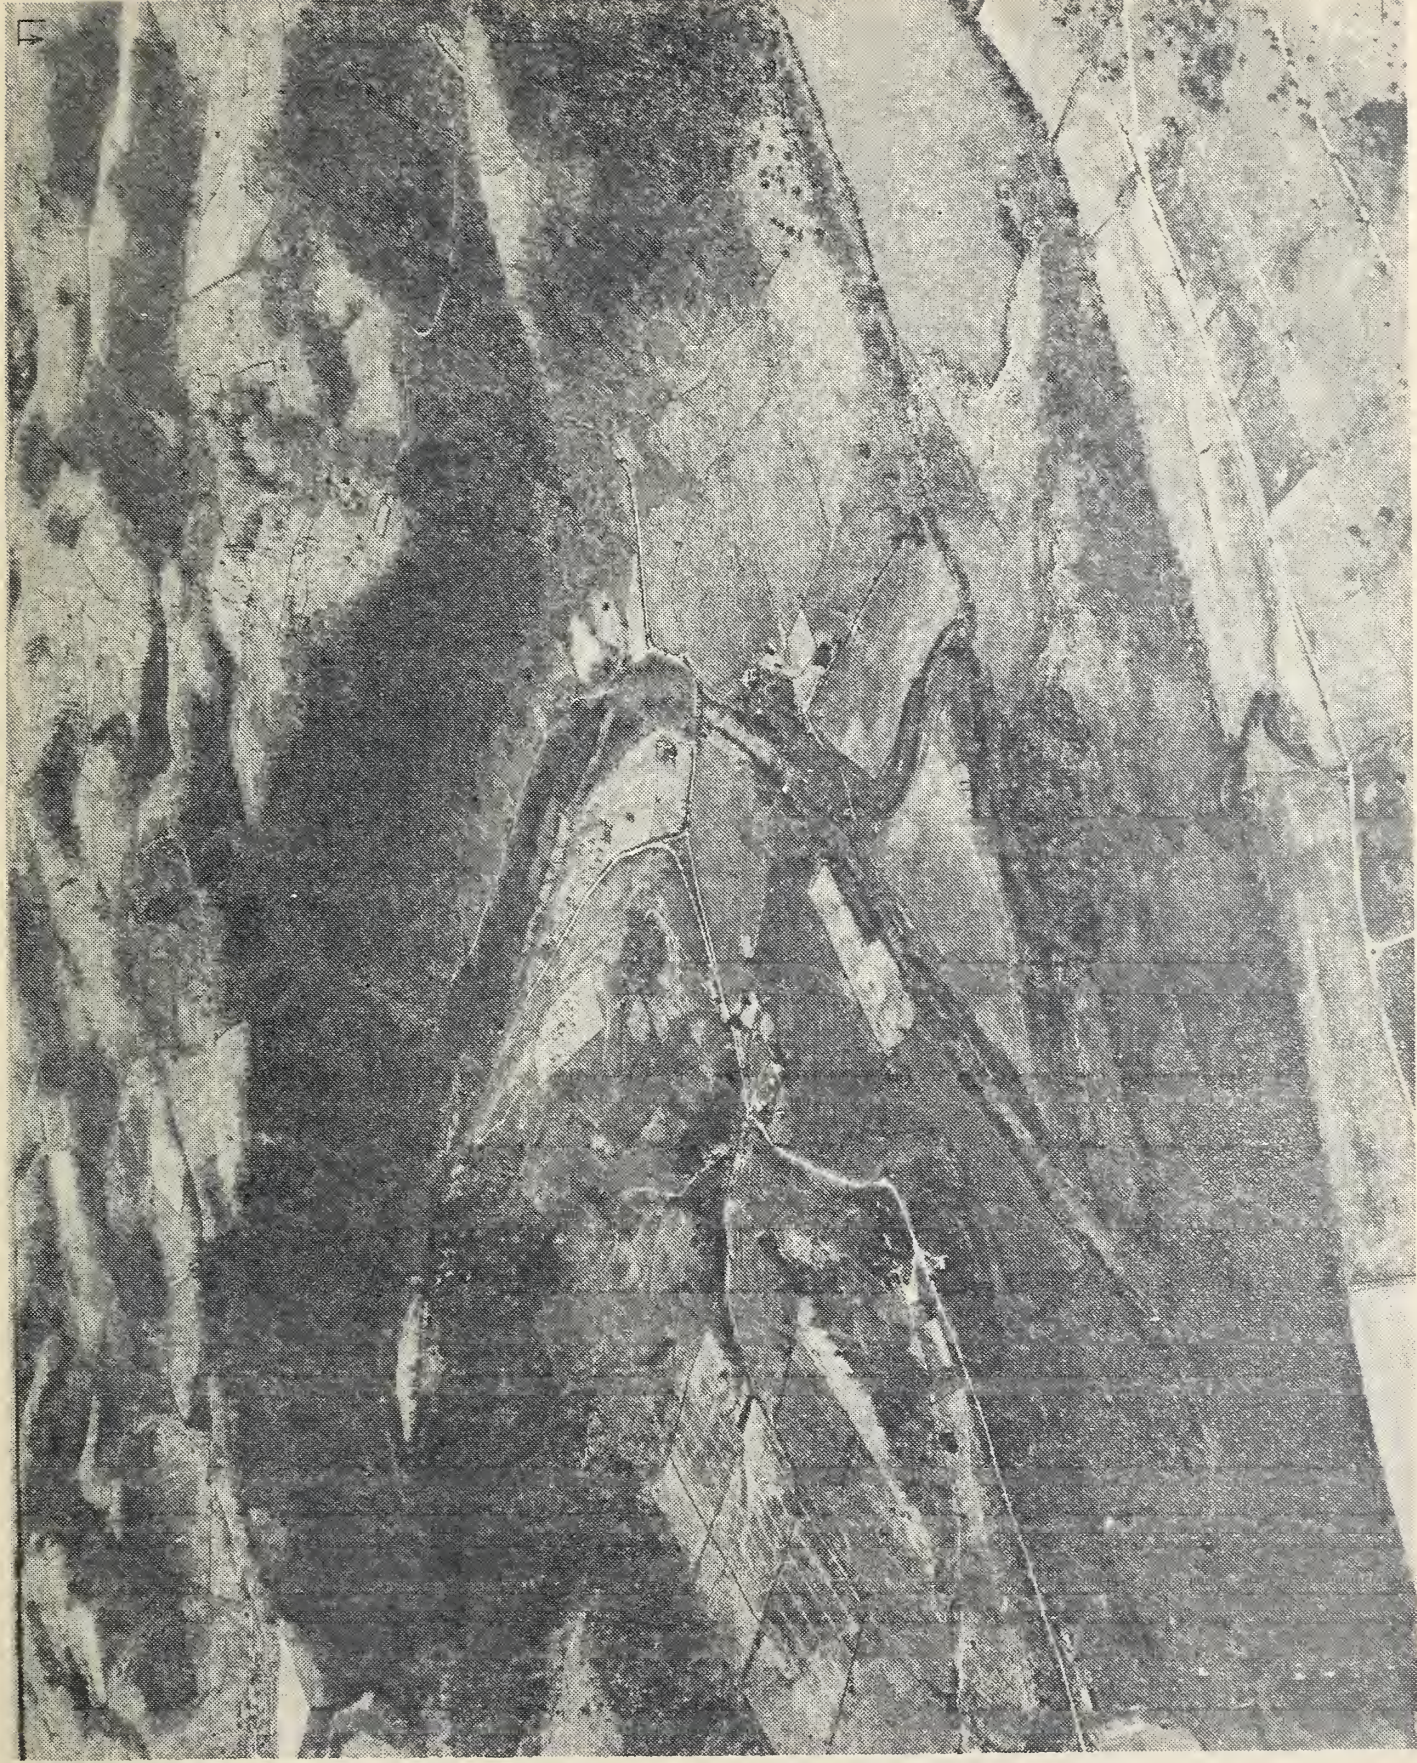
Figure 27. Navigation channel at the mouth of Indian Creek, about 18 miles above Hinton, W. Va. The channel extends diagonally across the riffles in the right foreground. (Courtesy of Aerial Surveys of Pittsburgh, Inc.)

Width-----	45 feet
Average depth-----	2.35 feet
Cross section area-----	105.73 square feet
Length of segment-----	522 feet
Observed surface velocity-----	6.21 ft. per second
Mean velocity (Obs. vel. x 0.85)-----	5.28 ft. per second
Character of bottom-----	Smooth bedrock
Discharge through channel-----	558.25 cu. ft. per second
Slope of segment-----	2.81 ft. per 1000 feet
Stage of New River at site-----	2.1 feet
Discharge of New River on same day-----	3,920 cu. ft. per second

The velocity in this channel, according to Parker's table, is sufficient to move stones 3 inches in diameter. It was found during the survey that the bottom was clean bedrock, free of all loose material.

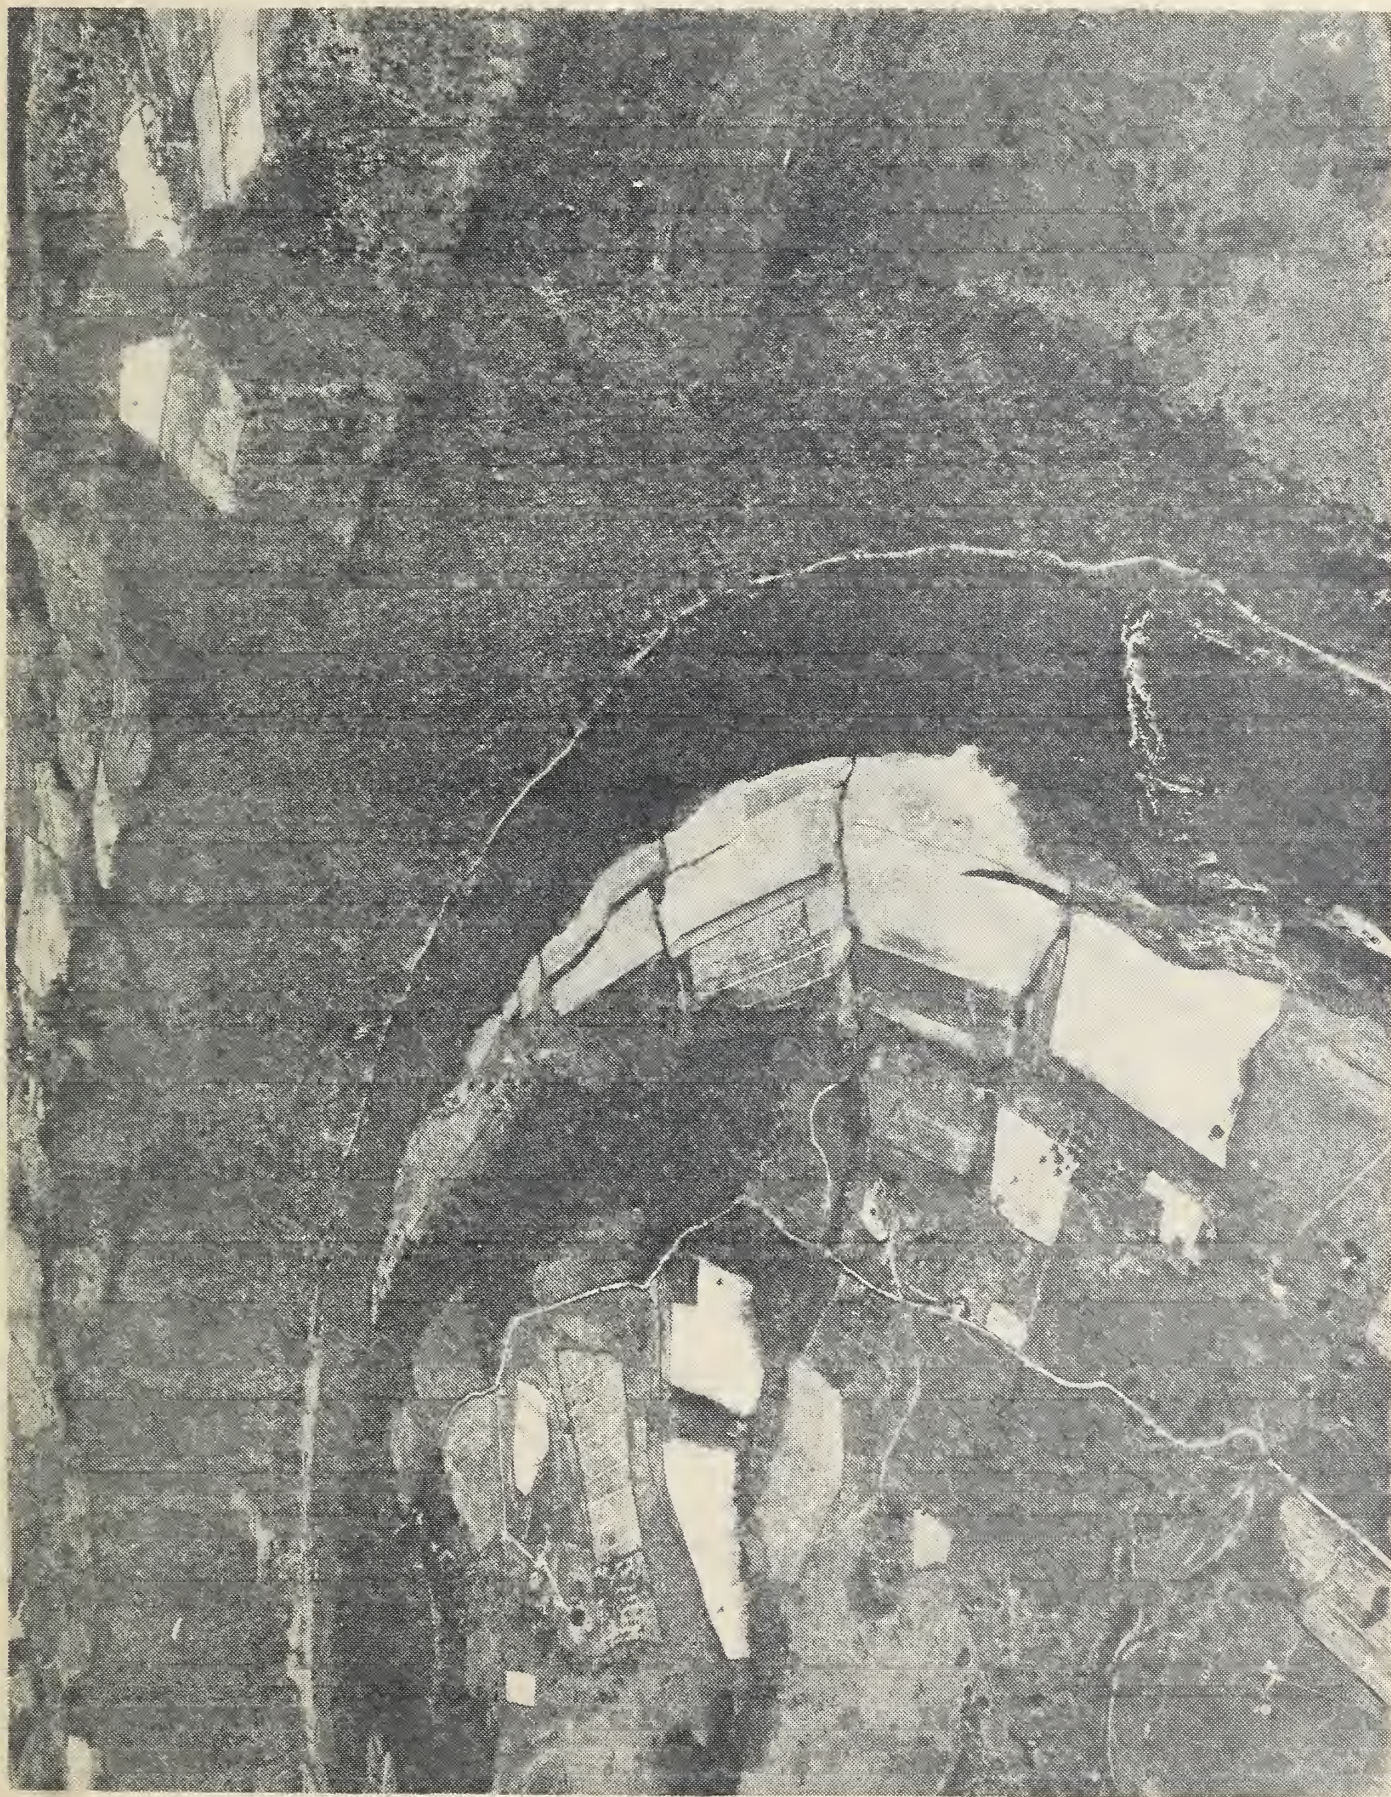
Figure 28. Navigation channel on the New River, about 20 miles above Hinton, W. Va.  
The spoil bank to the left of the channel is clearly shown above water level.  
(Courtesy of Aerial Surveys of Pittsburgh, Inc.)

Navigation channel 1-3/4 miles above the mouth of Indian Creek.--  
This channel lies near the right bank and cuts across an abrupt fall, with a total drop of 3.35 feet in a distance of 600 feet (fig. 28). One cross section was measured and velocities determined in three segments of the channel.

Width-----	41 feet
Average depth-----	3.32 feet
Cross section area-----	136.15 square feet
Observed surface velocity	
Upper reach-----	3.86 feet per second
Center reach-----	9.36 feet per second
Lower reach-----	4.08 feet per second
Mean velocity (Obs. vel.x 0.85)	
Upper reach-----	3.28 feet per second
Center reach-----	7.96 feet per second
Lower reach-----	3.47 feet per second
Character of bottom-----	Smooth bedrock
Discharge through center reach-----	1083.75 cu. ft. per second
Slope of center reach-----	9.65 ft. per 1000 feet
Slope of entire channel-----	5.36 ft. per 1000 feet
Stage of New River at Indian Creek----	1.9 feet
Discharge of New River on same day----	3920 cu. ft. per second

The survey showed that the center reach was floored with smooth bedrock, devoid of any loose material.
